TIGHT SPACES

MSB DISASTER RECOVERY SERVICES SAFELY PERFORMS A DANGEROUS CLEAN-UP BENEATH A HISTORIC BUILDING

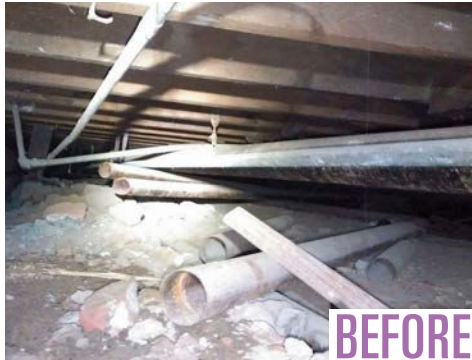
Before: Discarded building materials blocked passage inside the crawlspace.

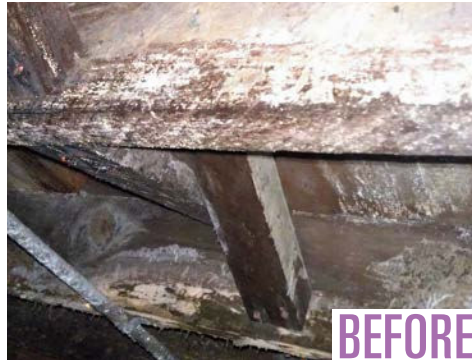
Before: The subfloor, seen here from the crawlspace, had been damaged by high levels of moisture and apparent mold growth.

To remediate the Category 3 water damage, workers used HEPA vacuums, hand scrapers and wire brushes to extract particulates. The bottom of the subflooring and joists were contaminated with microbial growth; once the

contaminated particulates were removed, the area needed to be disinfected. A peroxide solution was applied to the contaminated area. The foaming solution lifted materials to the surface and took about 24 hours to completely clean the surfaces. After the peroxide was applied, a disinfectant was used to kill the surface mold growth.

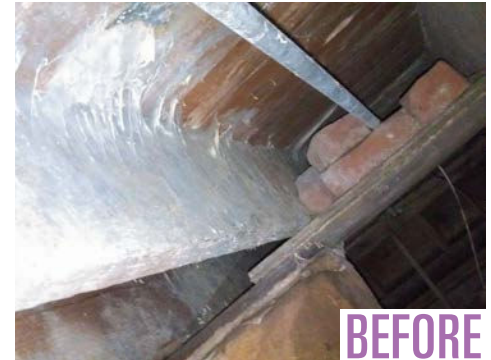
Before: The wooden structure in this photo had microbial growth caused by secondary damage from moisture.
